SOLUTIONS OUT OF THE BOX ENGINEERING SOLUTION SAVES MONTHS OF TIME ON IN-SERVICE INSPECTION

PIPING COMPONENTS & FLANGES

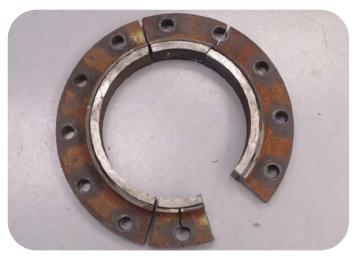
We received several broken flanges from a client in Alberta that had failed during bolting/torqueing. The flanges were expected to be made of "ductile iron" (DI), but they turned out

to be made of grey cast iron (with inferior mechanical properties). Metallographic examination of a larger batch revealed that none were ductile iron and were mostly compacted graphite iron (CGI; with somewhat lower ductility and tensile strength than DI) or grey iron (with almost nil ductility and much lower tensile strength).

Image of failed flange after sectioning

Instantaneous (overload) fractures upon bolting/torqueing
