# Pipeline Integrity Management of Unpiggable Pipelines – A Case History

by Arash Ilbagi, Ahmad Saab, and Frank Gareau  
Acuren Group Inc., Calgary, AB, Canada

## Pipeline Pigging and Integrity Management Conference

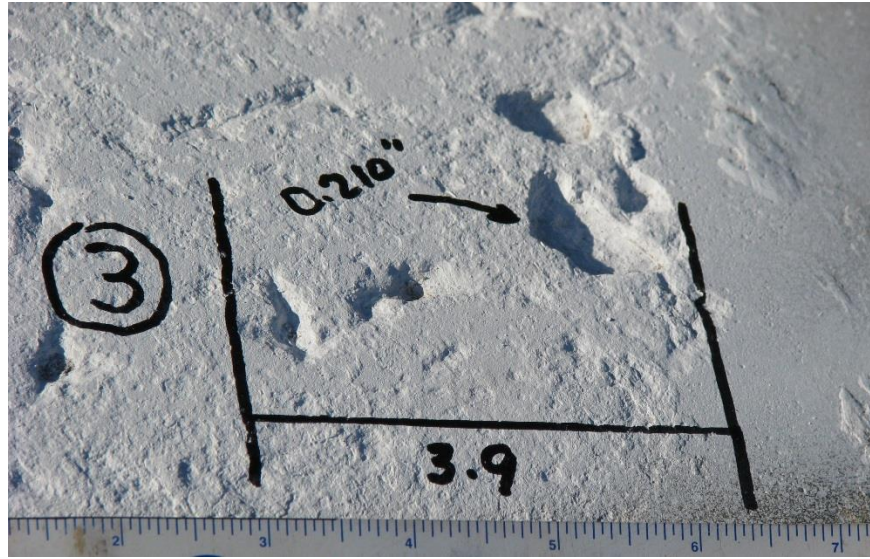
As per ASME B31.8S, Managing System Integrity of Gas Pipelines, the first step in managing pipeline integrity is identifying potential threats to integrity. Previously, the threat assessment had not been completed for these pipelines. The owner had performed 6 opportunistic dig inspections near its customer's plant as it was considered a higher consequence area and therefore of higher risk. No corrosion had been identified except for external corrosion at bends with field applied coatings. All the excavated bends were recoated to arrest the corrosion. With the corrosion at bends identified as an issue, it was decided to excavate the first bend about a mile from the upstream plant. This time, a significant amount of external corrosion was found along the straight section of the pipeline that had to be repaired as the anomalies failed the failure pressure criteria of ASME B31G, Manual for Determining the Remaining Strength of Corroded Pipelines. This unforeseen level of corrosion found on the 34" pipeline resulted in significant delay in selection and deployment of the repair solution. Figure 1 and 2 show the extent of corrosion and the completed repairs.

Figure 1. (a) External corrosion observed on the 34" natural gas pipeline, (b) External corrosion observed on the 4" LPG pipeline.

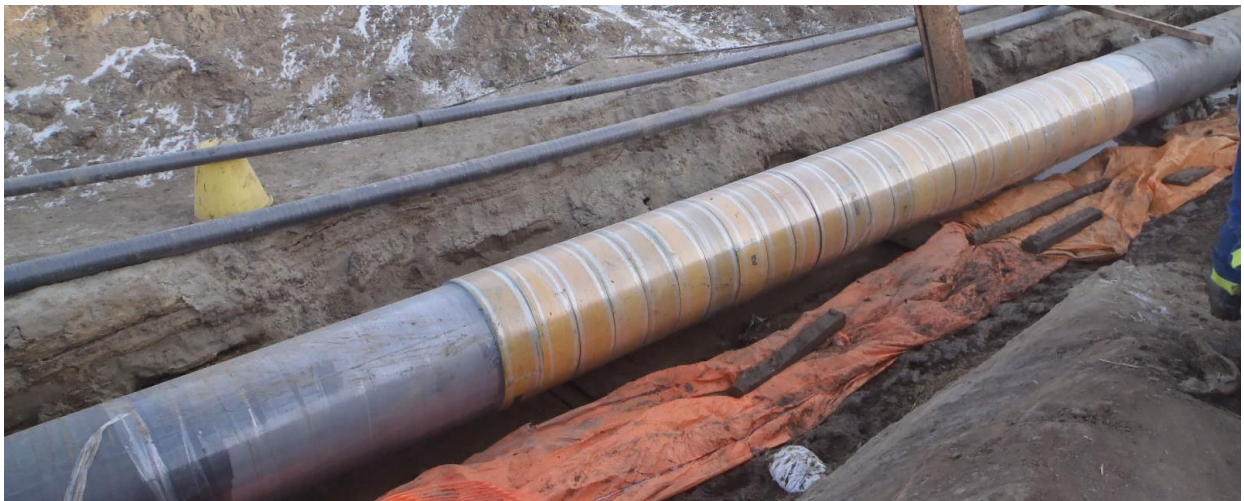
Figure 2. The 34" natural gas pipeline after the repair.

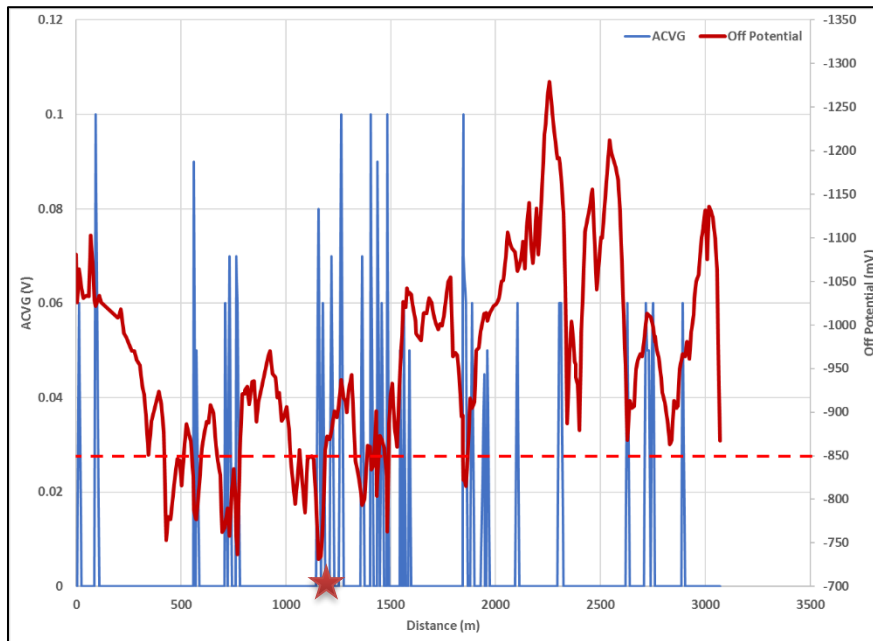
The results of CIPS and ACGV that were performed on the 4" LPG pipeline is shown in Figure 3. Very similar results were achieved for the 34" NG pipeline.

The results showed the pipeline's coating was damaged in several different locations. What was more concerning was the fact that the cathodic protection did not meet the -850 mV criterion for a significant length of the pipeline (from ~0.3 miles to ~0.9 miles).

While the pipeline owner was evaluating this result and was planning to perform the verification digs, the 4" pipeline suffered a failure and leaked. The failure was due to external corrosion and its location is shown on the horizontal axis of Figure 3, at about 0.7 miles length. At this point, the location of the failure was exposed and both 4" and 34" pipelines were inspected. As expected from the ACGV survey, the condition of the coating of both pipelines near the failure location was poor, and moderate to severe metal loss had occurred. It was concluded that while both pipelines experienced similar external corrosion mechanisms, the 4" pipeline failed earlier due to the thinner wall thickness. At this point, it was decided that the operations of both pipelines be placed on-hold, until further inspection is completed, and a more detailed action plan is developed to reduce the risk of failure of both pipelines.

Figure 3. Result of CIPS and ACGV for the 4" LPG Pipeline. The dashed line indicated the -850 mV criterion. The red star shows the failure location.

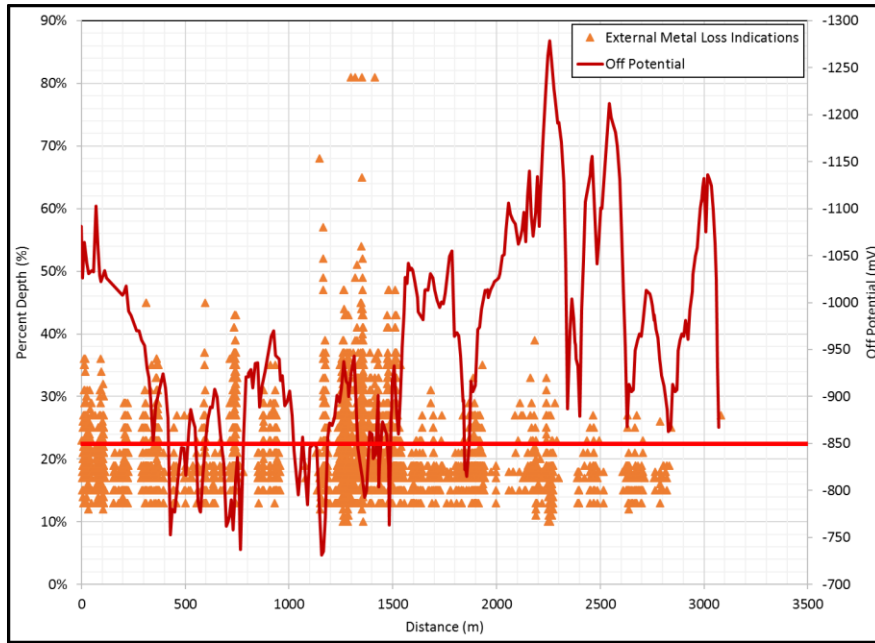
Figure 4. Result of ILI Superimposed by CIPS Data.

After the pipeline failure, a high resolution bi-directional magnetic flux leakage (MFL) ILI tether tool was utilized to inspect the 4” pipeline both upstream and downstream of the failure location. Figure 4 shows the results of the ILI. External corrosion was found along the length of the pipeline. In some areas the metal loss was more than 80%.

After alignment of the data from CIPS and ACVG with the metal loss indications from the ILI, it was found that the corrosion was more severe at locations where the cathodic protection did not meet the -850 mV criterion and where ACVG indicated coating holidays (Figure 4).

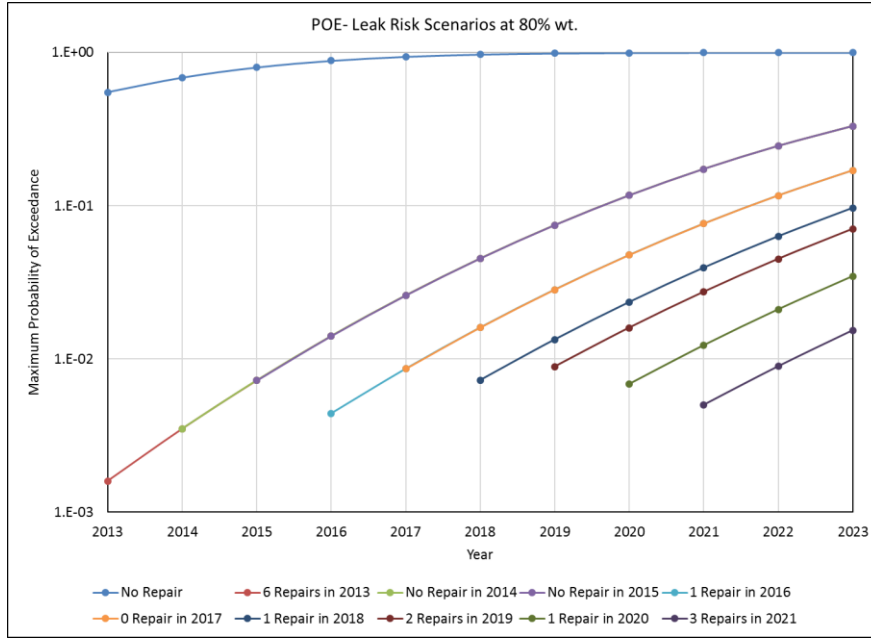
Figure 5 and 6 show the POE-Leak scenarios and POR-Rupture scenarios. The figures show that, with the completion of the repairs each year, the maximum probability of exceedance to 80%WT and rupture is significantly reduced to a level that is tolerable to the company.

Figure 5. POE-Leak Risk Scenarios

A total of 244 indications must be removed/repared within the next 10 years from the date the ILI was completed in order to keep the risk within a tolerable range for the company. Based on these results, 500 feet of the 4” pipeline was replaced; this significantly reduced the number of digs that were required in the upcoming years.

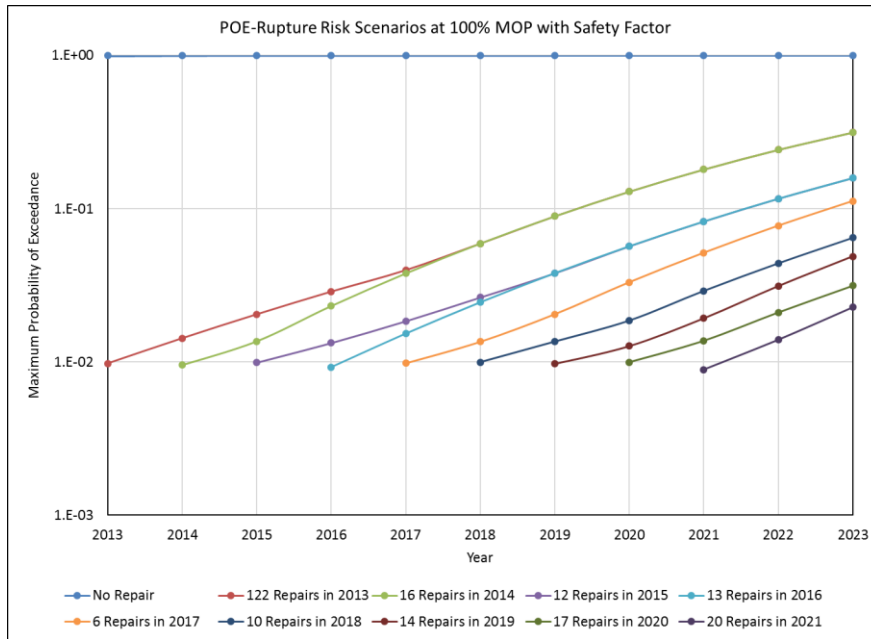
Figure 6. POE-Rupture Scenarios
