Corrosion of Galvanized Piping in Domestic Water Systems

By Catherine A. Noble, P.E., Principal Engineer
(from the *Conduit*, Vol 13, No 1)

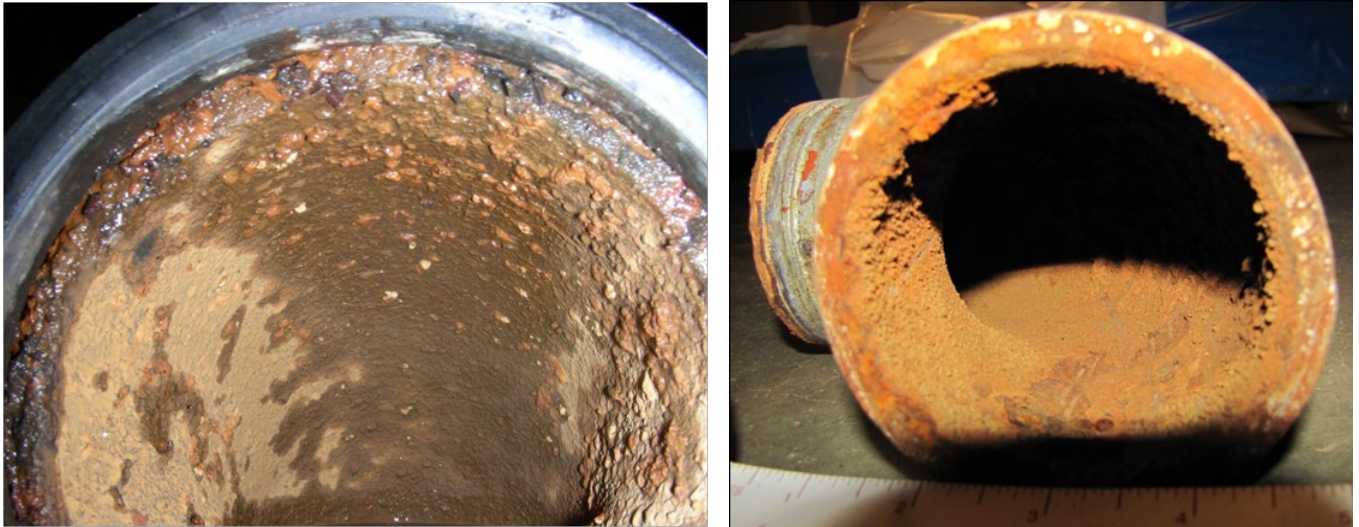
Hotels, high-end residences/condos, stadiums, hospitals, etc. often have specifications that require the builder to use copper pipe for all potable water piping that is two inches in diameter or smaller, but may allow substitution of other suitable materials for larger piping. Large hot water systems in these types of complexes that use circulated hot water have defaulted to using galvanized carbon steel piping for these larger diameter pipe sections. This is due to the lower cost of galvanized pipe compared to copper or other materials. The degradation of the galvanized piping in a soft water system can occur in a short period of time, and problems can arise in as few as two to five years after a new installation (Figure 1). This degradation is a major issue that should be addressed.

Softened water is actually aggressive (corrosive) to carbon steel and galvanized materials. The zinc (galvanized) layer on the steel pipe gains much of its protection from a zinc carbonate layer that forms on the surface. The presence of some hardness (calcium carbonate) in the water is beneficial, as it aids in forming the protective layer. In addition, the combination of a thin layer of calcium carbonate with the zinc carbonate is more resilient to corrosion than zinc carbonate alone in completely softened water. When hardness has been fully removed, the protective layer does not properly form and the zinc layer is susceptible to corrosion. In this situation, the galvanized layer first acts as a sacrificial anode and corrodes preferentially to the steel underneath it. However, once the zinc is completely gone, the steel pipe itself

Figure 1. Examples of corrosion in galvanized piping in hot, softened water service.

The bottom line is that galvanized piping should not be used for hot, softened water service, regardless of how much cost savings is gained. It is just a matter of when it becomes a corrosion issue, not if it will. Any piping after the softener should be made of copper or some other suitable material that does not experience accelerated corrosion rates in hot softened water, such as PVC or stainless steel.

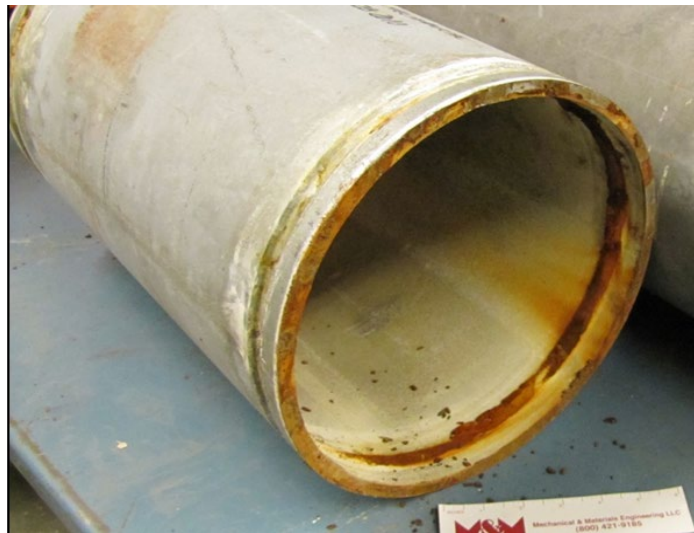
Another issue with using galvanized piping is that the pipes are often threaded or seam rolled in the field during installation. This destroys the galvanized layer wherever the machining or rolling takes place. Sometimes these areas are covered over with zinc-rich paint or primer after forming, but this does not provide as much protection as the original zinc coating. Therefore, corrosion often occurs first at threaded fittings, seams, or rolled grooves in the galvanized pipe (Figure 2).

Figure 2. Corrosion along a rolled joint at the end of a galvanized pipe section.

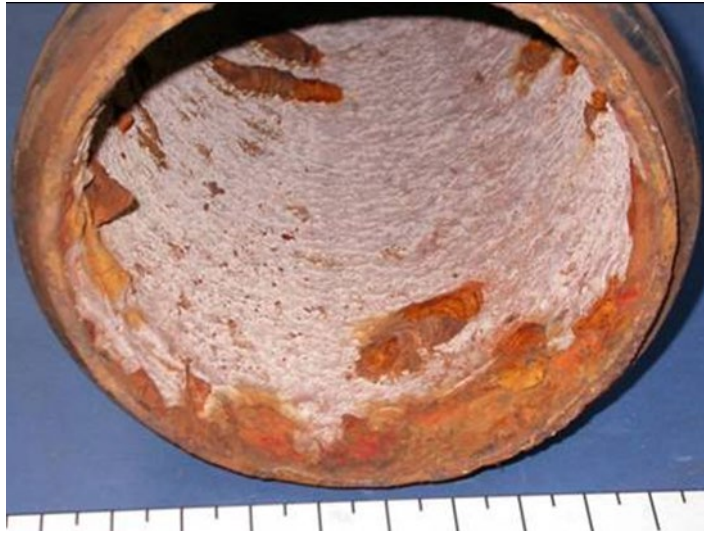
Figure 3 shows a water pipe from a hotel with internal corrosion that led to multiple complaints about rusty water. Severe pitting was noted on the internal surface of the pipe (Figure 4 and Figure 5). In addition, most of the piping samples had no remaining galvanized layer present, particularly after the softener. This system was only six years old, and much of the piping had to be replaced. Figure 6 shows a pipe from hot, softened domestic water service in a stadium. Much of this piping system had internal corrosion, and failures had also occurred. This pipe was only two years old, and thousands of feet of piping were replaced in the facility.

Figure 3. This galvanized pipe was examined after six years in service. This sample was from the cold, softened water line prior to the heat exchanger, but after the circulating hot water return. Pitting was significant.

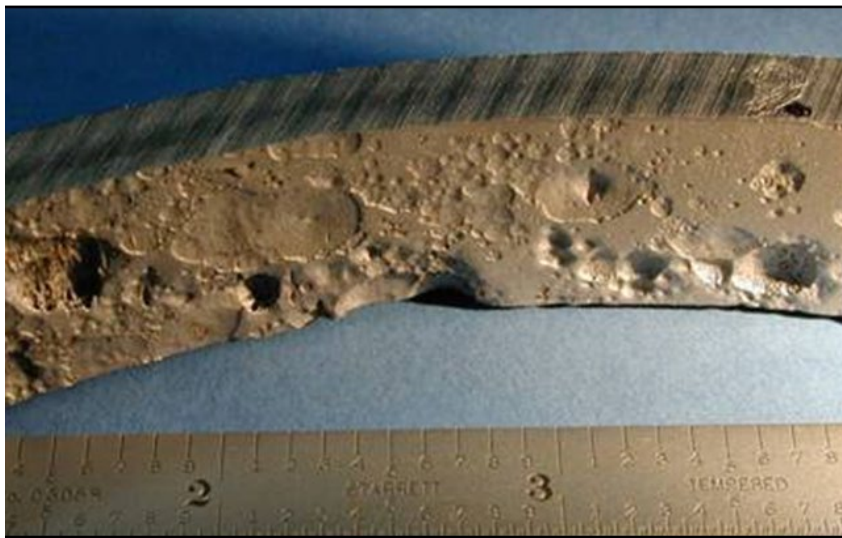
Figure 4. Multiple pits were noted on the internal surface of the galvanized pipe after cleaning.

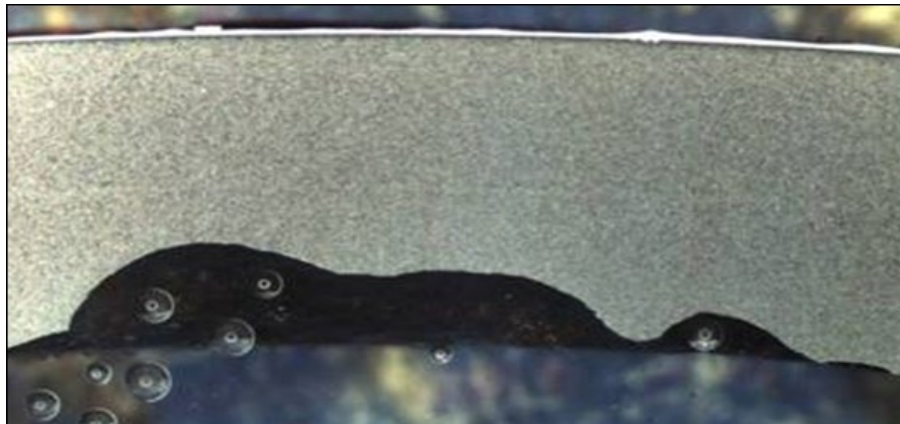
Figure 5. Cross-section of galvanized pipe shows the severe nature of the internal pitting.

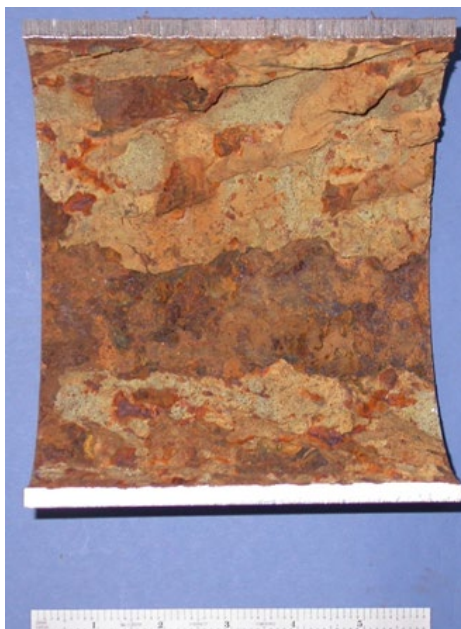
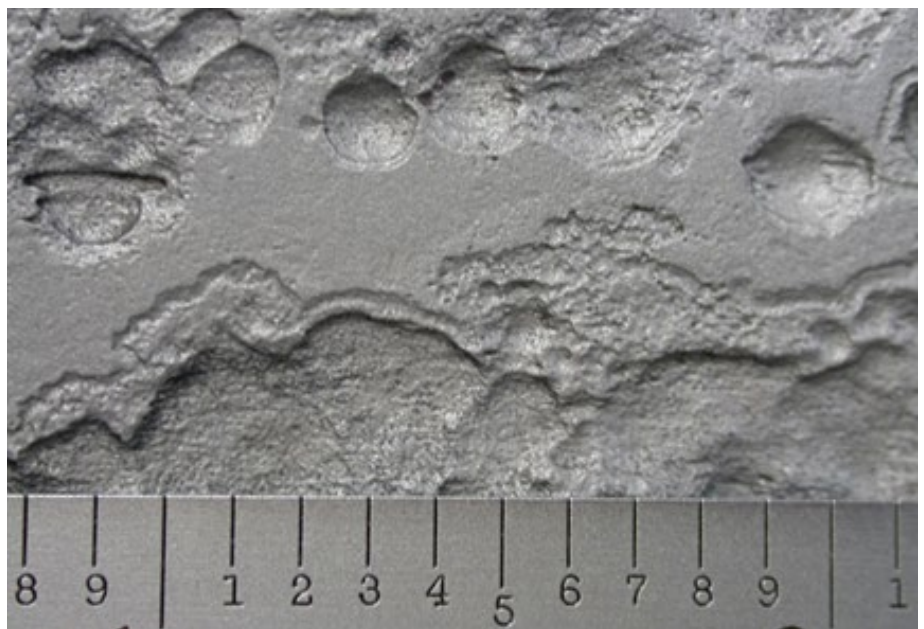
Figure 6. Internal surfaces of galvanized pipe from a hot, softened water line that was examined after two years in service. Pitting was significant on both sides of the pipe, but worse on the bottom of the pipe (shown here before and after cleaning).
