Dew Point Corrosion – A Case Study

**By: Oscar Quintero, Principal Engineer and Catherine A. Noble, P.E., Principal Engineer
(from the *Conduit*, Vol 13, No 2)**

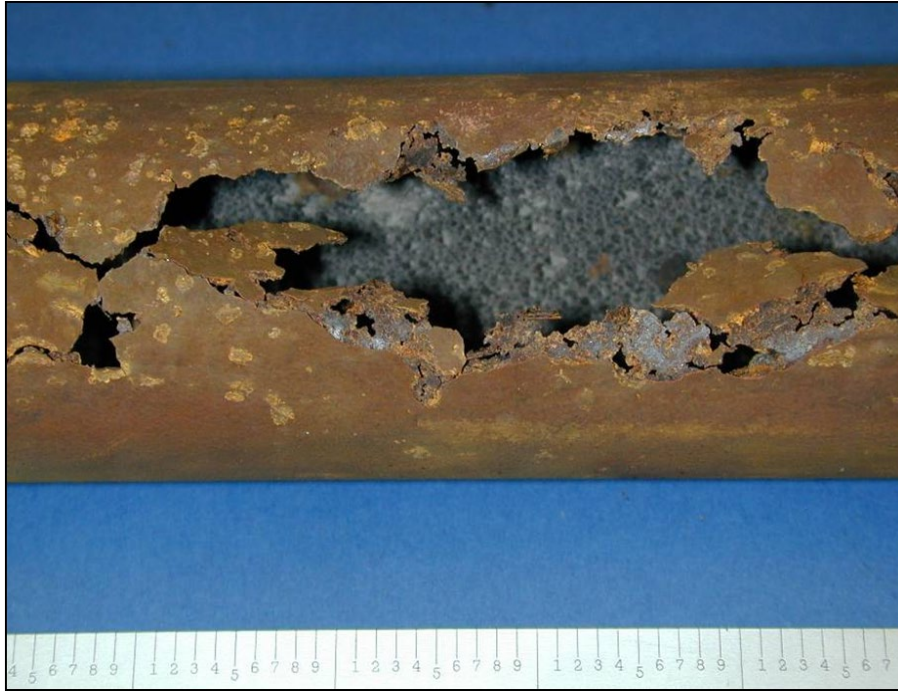
The tube came from a boiler that burns bark, tire-derived fuel, and gas fuels. It has a flue gas temperature between 480 and 500°F during normal operating conditions. The as-received tube section is shown in Figure 1.

The air heater tube section exhibited corrosion on the external surface of the tube. The ends of the tube were badly damaged. In addition, the wall thickness was extremely low. A perforation was noted over most of the length of tube. Cross-sections from the air heater tube were removed at the failed area and at an area remote to the failure. The cross-sections were prepared using standard metallographic techniques of mounting, grinding, polishing, and etching. Severe wall thinning of the air heater tube was observed in the perforated area (Figure 3). The cross-section opposite from the perforation revealed deposit accumulation as well as severe wall thinning. The typical microstructure for all the air heater tube sections consisted of pearlite and carbides in a ferrite matrix. There was no heat damage observed in the microstructure of the air heater tube. In addition, no material defects were noted that contributed to the failure.

Figure 1. The air heater tube section in the as-received condition.

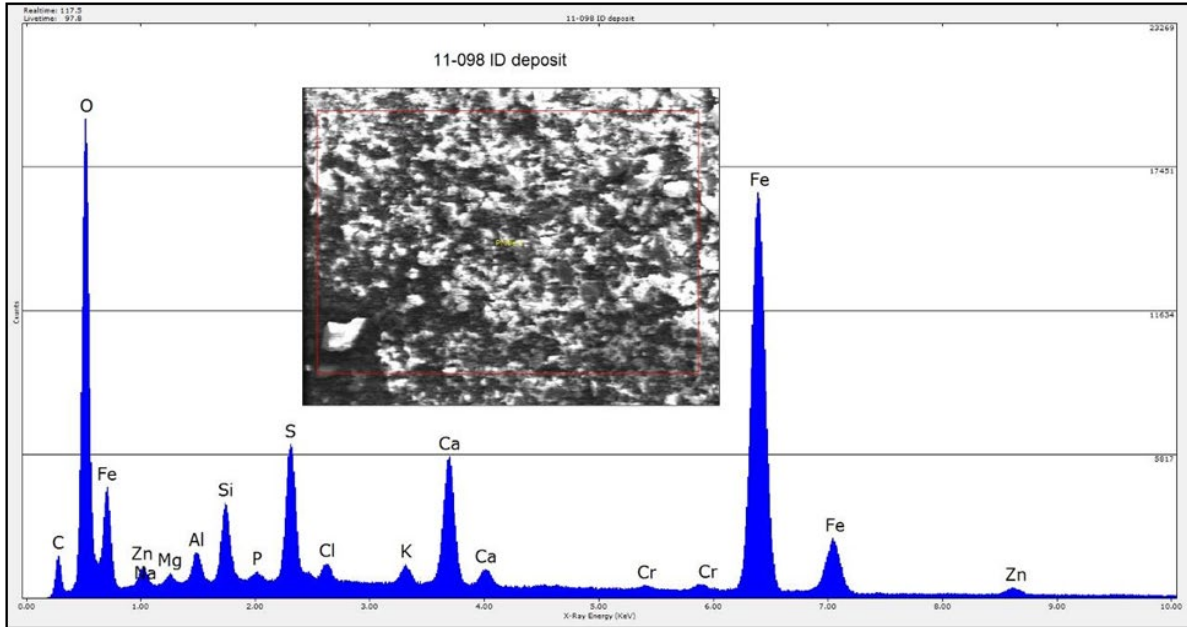
The deposits collected from the internal surface of the tube were analyzed *in-situ* using the scanning electron microscope (SEM), where elemental analysis was performed using energy dispersive X-ray spectroscopy (EDS) to determine their composition. The EDS spectrum of the chemical composition of the internal deposits is shown in Figure 2.

The deposits consist mostly of iron and oxygen. Lesser amounts of carbon, aluminum, silicon, sodium, calcium, and zinc were present. In addition, trace amounts of sodium, magnesium, phosphorus, chlorine, potassium, and chromium were present. In this case of dew point corrosion, elements such as sulfur and chlorine in a wet environment can react with the cooled vapors to form acidic compounds such as a low concentration of sulfuric acid, which is very corrosive to carbon and low alloy steels such as COR-TEN™.

Figure 2. EDS spectrum of the chemical composition of the deposits collected from the internal surface of the heater tube.

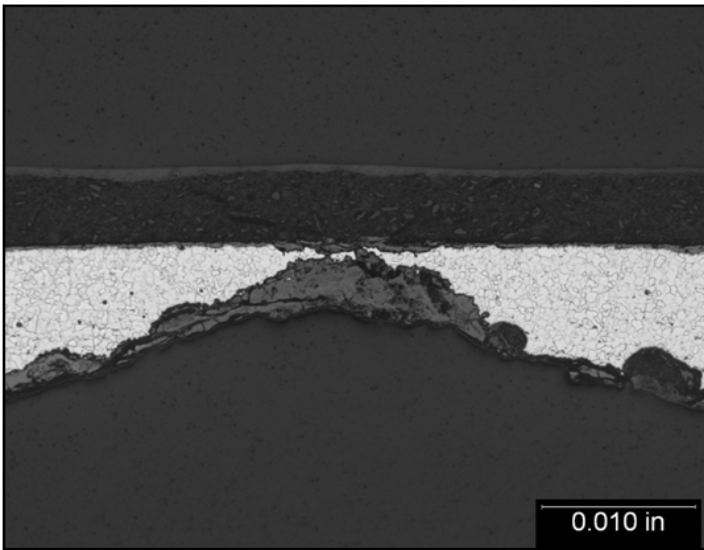
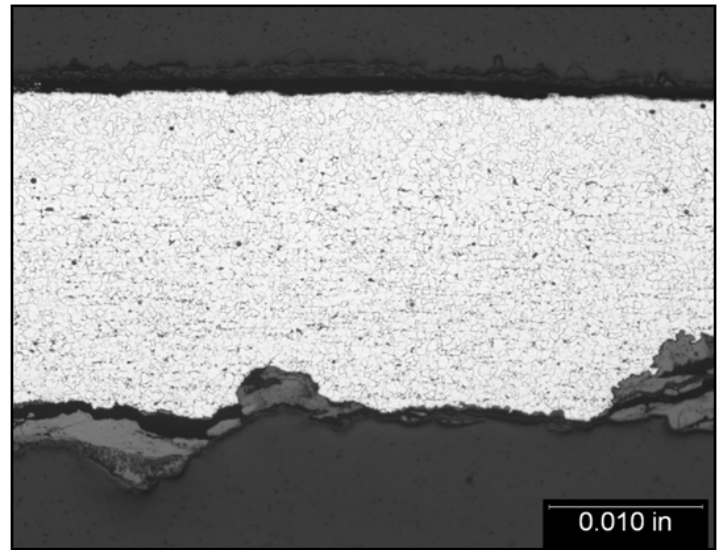
Perforated Area

Figure 3. Micrographs show the typical view of the perforated area (top images) and remote from the failure (bottom image) of the primary heater tube.
