# Sample Removal and Shipping...

## What NOT to Do

**By: Catherine A. Noble, P.E., Principal Engineer**  
**(from the *Conduit*, Vol 17, No 2)**

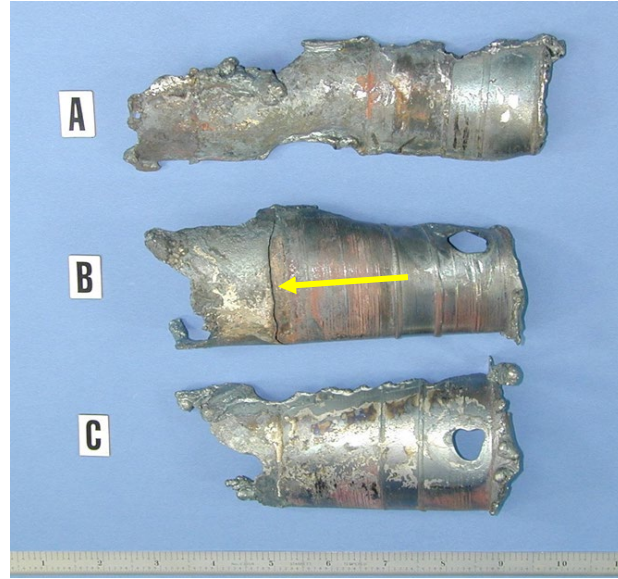
While saw cuts will remove a thin section of the part, they are much preferred to torch cuts. In addition to producing more metal loss, torch cutting causes significant heat damage to the part several inches around

the cut (as shown earlier in Figure 1). This can obscure whether the part was overheated prior to or as a result of the failure. If torching is used, it is best to cut 12 to 18 inches away from either side of the area of interest to avoid damaging the microstructure in that area.

Figure 1. Sections of a boiler tube that were received for analysis. The tube was torch cut for removal from the mud drum, but a section of the crack was still preserved (arrow).

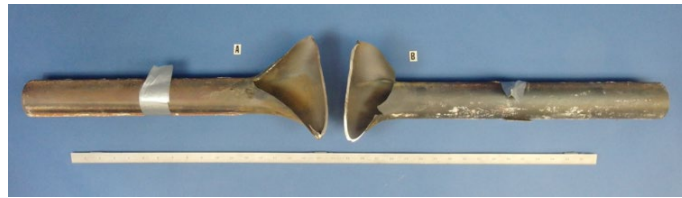
For the first example, this tube was received with a saw cut through the middle of the rupture (Figure 2). It appeared that this was done in order to fit the tube into a shorter box. In this case, we were still able to determine the failure mechanism (short-term overheating), but cutting through the failure area runs the risk of removing or damaging an artifact of the failure that would indicate the mechanism or more importantly in some cases, the initiation site. Sometimes we want to look at the middle of the failure, but might also want to look at the edges of the failure or adjacent to the failure to gain more information.

Figure 2. A boiler tube that was cut through the middle of the rupture prior to shipping.

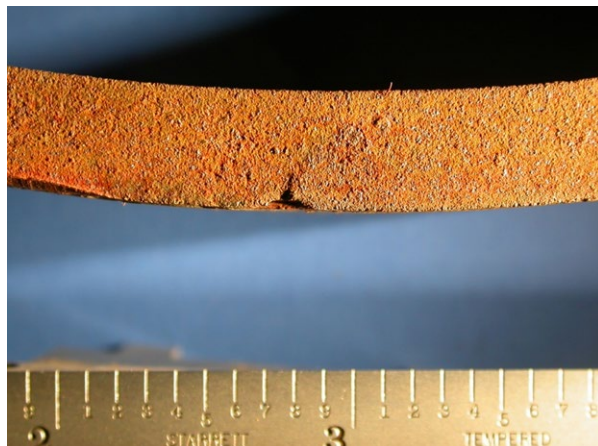
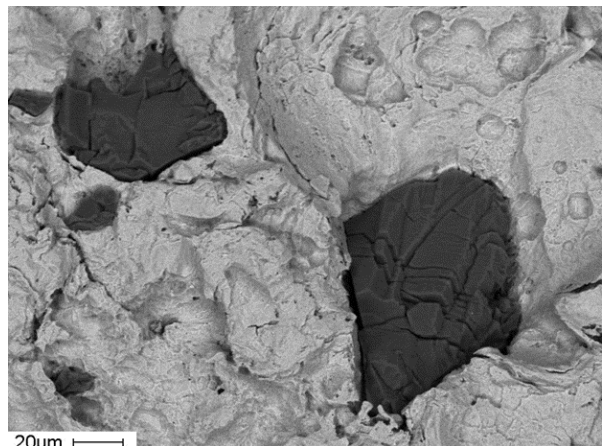
Another cleaning method that can cause even more damage is grit blasting. Figure 3 shows a sample we received that had been grit blasted, including the fracture surface, to remove deposits. At first, it just appeared that the fracture was very smooth and flat. Examination at high magnification showed particles imbedded in the fracture from cleaning and dulled fracture features. This made it difficult to confirm the failure mechanism. Any grit or bead blasting of or around the fracture should be avoided to keep the damage morphology intact.

Figure 3. Sample that was grit blasted to clean it prior to shipping. Sand particles (black areas in lower right image) were found imbedded in the fracture from cleaning.

Fracture surfaces should be carefully masked from any exposure to grit/bead blasting. Chemical cleaning methods can also cause similar damage if the part is exposed to the chemical for too long or without corrosion inhibitors.

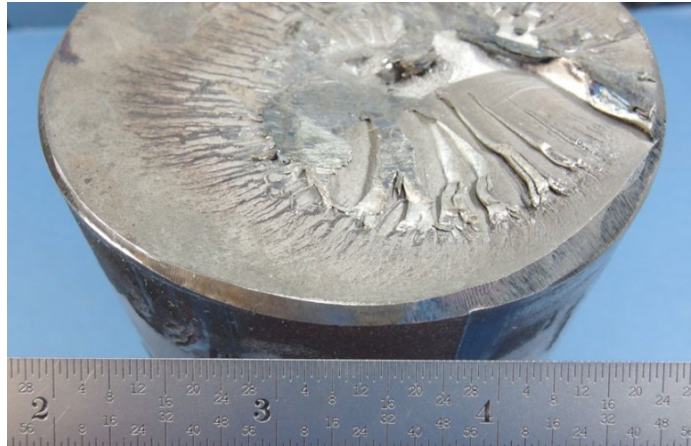
Figure 4 shows a failed shaft that was received for analysis. The customer indicated that they machined around the circumference of the part to smooth the sharp edges for safety purposes. While this was considerate, it also removed the likely origin of the fracture, as these tend to be along the surface of the shaft. It is best to avoid any machining, smoothing, or beveling of parts.

Figure 4. Shaft where the circumference was machined to bevel the edge.

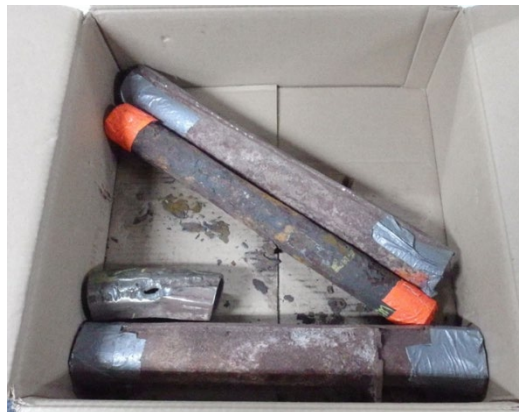
When shipping samples in a cardboard box, they should be packed in an appropriately sized box with cushioning packing material inside. Some clients use old rags or newspaper – it doesn’t have to be brand new bubble wrap. When no packing material is used, the parts bang around in the box

during shipping, which can shake loose deposits or cause additional damage (Figure 5). This makes it difficult to discern whether the damage was due to the failure or shipping. We have also seen a loose tube go through the side of a box and get lost because it was able to move around too much in a large container.

Figure 5. Box with four boiler tube sections and no packing material. Deposit can be seen that fell off of the tubes in the bottom of the box.

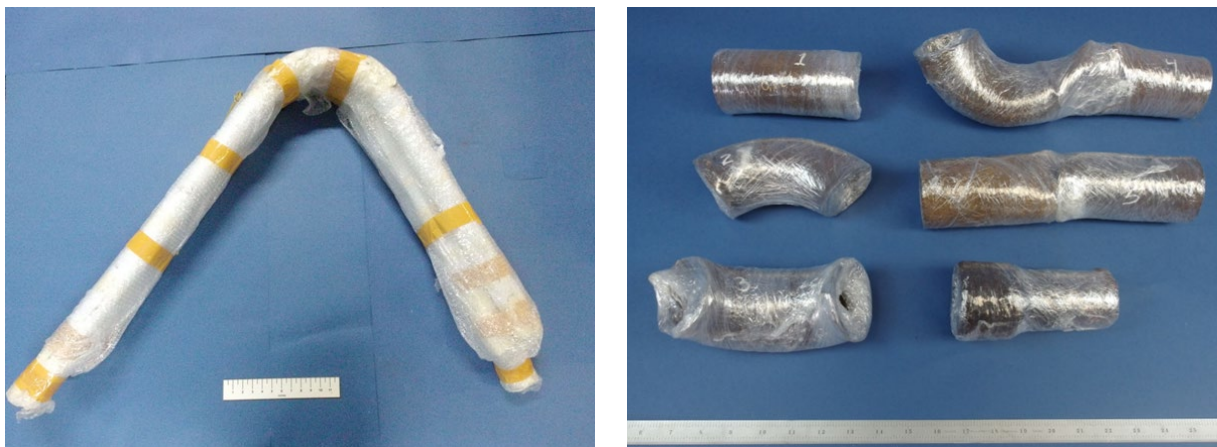
In addition to padding the samples inside the box, the failure itself should be well protected (Figure 6). Wrapping the failure can also prevent damage during shipping, even if loose packing material is used around it. For example, if a fatigue fracture is impacted, it can damage the fracture and make it difficult or impossible to find the crack origin, or determine if it was high cycle or low cycle fatigue. This can easily happen

Figure 6. Examples of well protected samples.

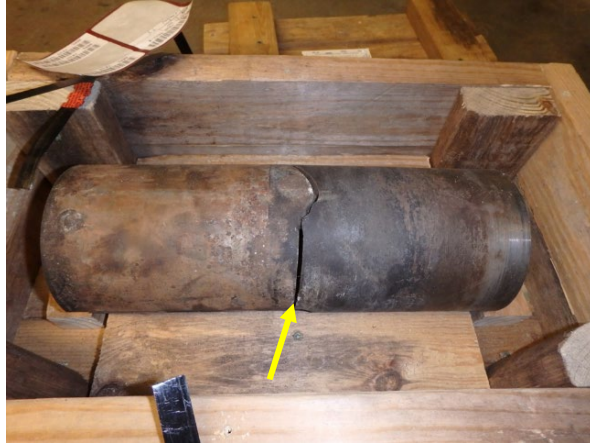
One item specific to fracture surfaces is to **not** put the mating fracture surfaces in contact. It is natural to want to fit the mating halves back together to see how well they match. However, even lightly fitting the halves back together can cause rubbing damage to the fine fracture features, particularly in the origin area. Avoid the natural tendency to put the pieces back together. We recently received a fractured shaft that was placed in a nice, custom-made wooden box for shipping (Figure 7). Everything was well protected and packed, except that the mating fracture surfaces were secured into the box touching each other. This means that they impacted against each other during the entire shipping process, over 1000 miles, until we removed them from the box. If it is necessary to secure a fracture surface for shipping, place the fracture against a wooden support. The fracture halves shown in Figure 7 could have been successfully shipped if a wooden piece (2x4, piece of plywood, or even a stack of popsicle sticks) had been placed between the two fracture surfaces to prevent them from contacting one another during shipment.

Figure 7. Fractured shaft that was packaged with the mating fracture surfaces touching (arrow).

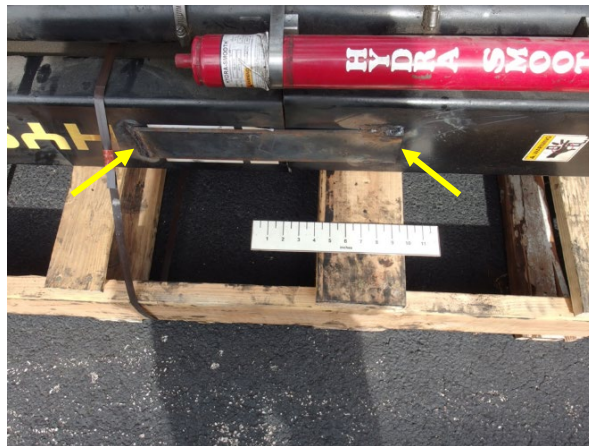
Sometimes parts are welded together for removal or shipping. In some cases, this is good because it maintains a space between the mating fracture surfaces (Figure 8) to

Figure 8. Fractured forklift boom, where a plate was tack welded (arrows) to maintain a space between the fracture surfaces.

avoid the situation described above. In other cases, a handle might be welded onto the part that happens to be welded onto the failure area. When welding on failed components to aid in sample removal or shipping, be mindful of keeping space between the fractures and avoiding welding too close to the failure and causing unwanted heat damage.
