PROJECT SPOTLIGHT FLARE STACK – EXTENDING OPERATING LIFE OF CRITICAL LEGACY ASSET

MINIMIZE RISKS AND EXTEND OPERATING LIFE

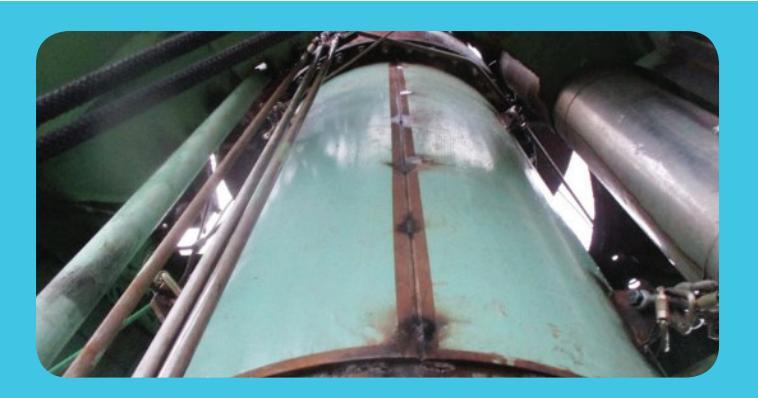
Internal view of

stack with drone

- Advanced thinning of top six (6) feet of stack pipe
- Large circumferential crack in stack pipe at flare tip flange
- Flare tip cracking
- Holes in stack pipe under clamps
- Slight progression of general thinning
- Failed ladder and piping attachments
- Cracking confirmed with internal drone
