API 579 FFS Assessments of Storage Tanks with Uneven Support

Alex Tatarov, Principal Engineer at Acuren
Arash Ilbagi, GM-Engineering at Acuren

MAY | JUNE 2023

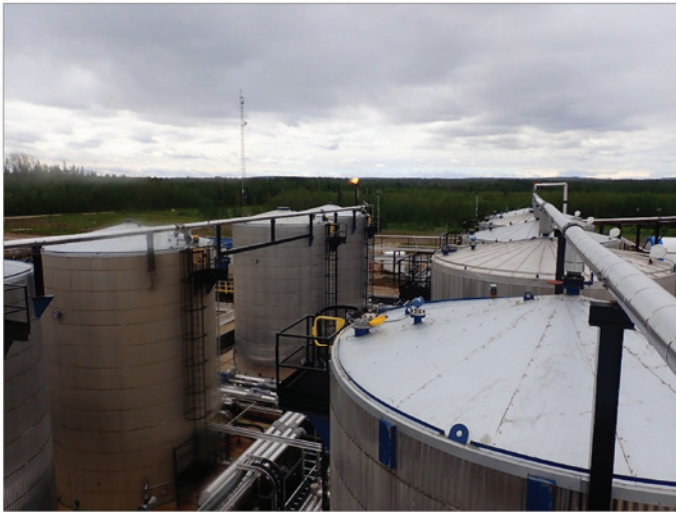
Figure 1. Overview of the tank farm.

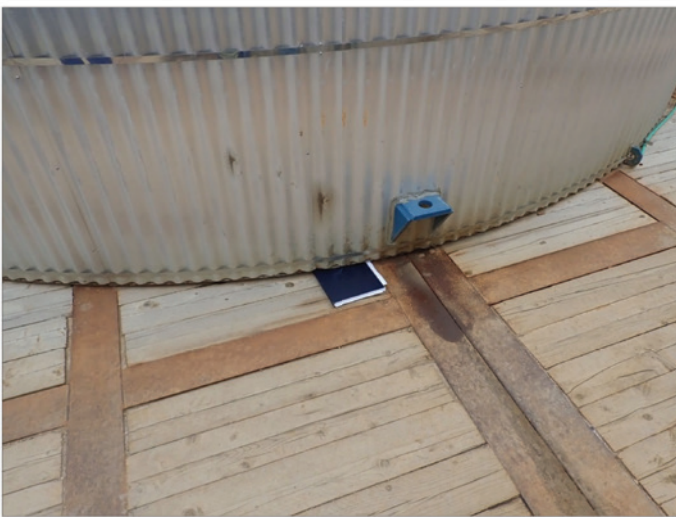
In a tank farm located in a permafrost area in Northern Canada, eleven atmospheric storage tanks were installed on rig mats. Visual inspection revealed gaps between the mats and floors of several tanks, as shown in **Figures 1-3**. The following is the design information for the tanks in the subject tank farm.

Figure 2. Gap between tank floor and supporting mat.

Table 6 shows the allowable fill level of tanks in static condition, that was calculated within assumptions of this report and based on the shape of peripheral gaps determined by visual inspection. It was also recommended to reduce the number of liquid level variations and internal pressure variations to reduce the likelihood of dynamic failure mechanisms until the owner can remediate the foundation instability.

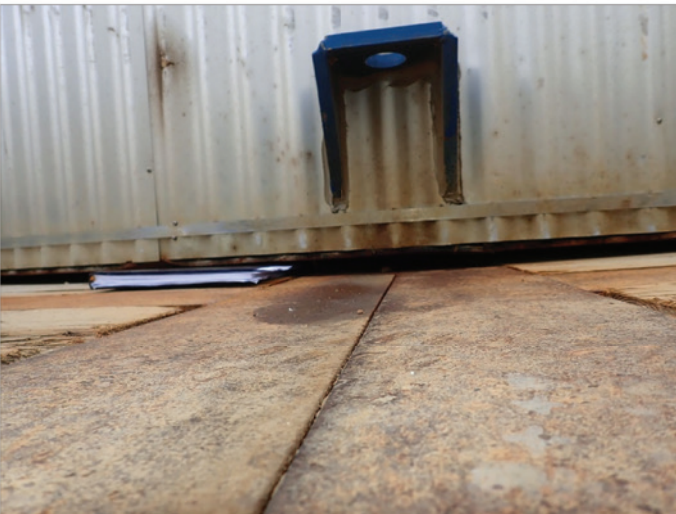
Figure 3. Same as Figure 2: closer view.

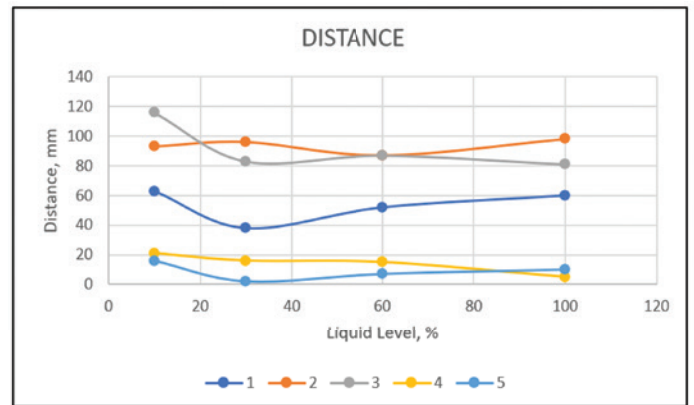
Figures 5 and 6 show the results of the measured deflection for five of those tanks as a function of the liquid fill level in each tank. Similar results were observed for all tanks. These results showed that the foundation supports of these tanks are not solid.

Figure 5. Deflection Distance vs. Liquid Level. (Deflection Distance: Length of the Deflection Vector Between the Reference Point [Vertical Position] and Roof Tip)

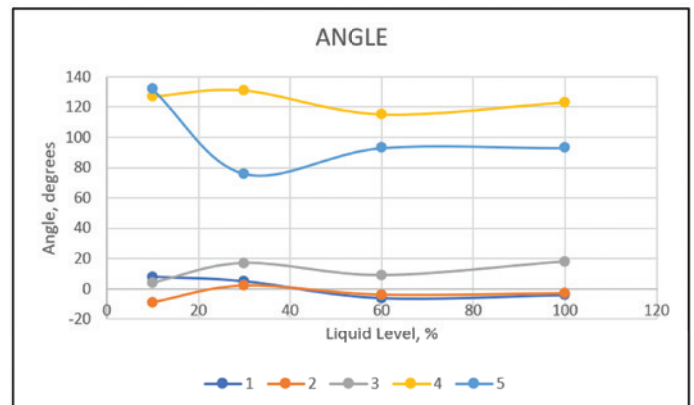
Figure 6. Deflection Angle vs. Liquid Level. (Deflection Angle: Angle of the Deflection Vector with Respect to the North Direction)

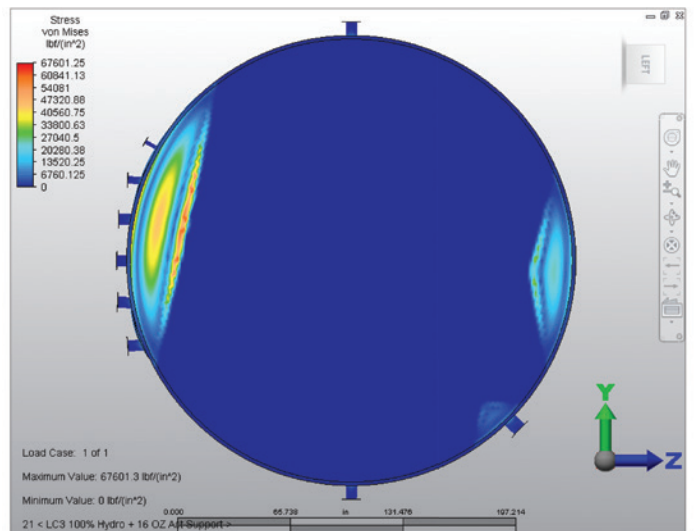
Figure 12. Stress Distribution in Tank 1 at 100% Liquid Level: Not Acceptable

Figure 10 shows support conditions of Tank 1 with 100% liquid level. Figures 11 and 12 show the floor displacement and stress distribution at 100% liquid level. Figures 13 and 14 show the stress distribution at 60% and 39% liquid levels.
