EMERGENCY ENGINEERING EXPERTISE RESTORES CRITICAL ASSET TO OPERATION

MIDSTREAM | SULFUR CONDENSER

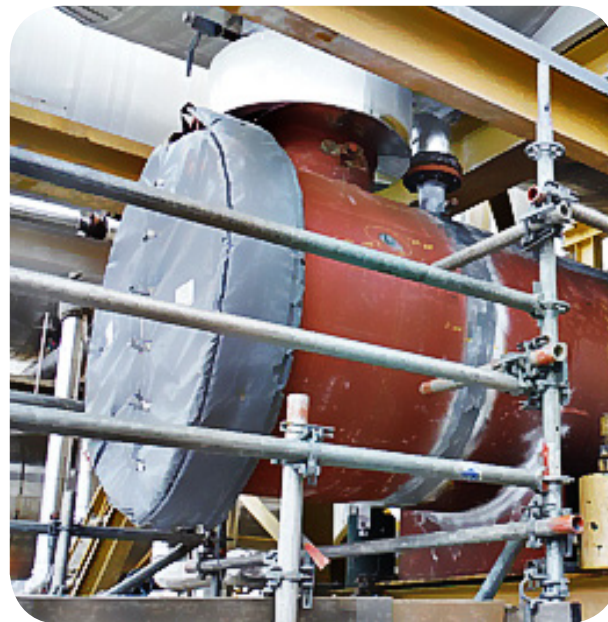
The asset involved was a sulfur condenser. A sulfur condenser is installed downstream from each catalytic reactor to condensate, and make feasible, the separation of the elemental sulfur before entering the next catalytic reactor. It is a critical asset and without it, the entire feed acid gas would have to be potentially flared.

Sulfur condenser located in a sweet and sour gas processing facility

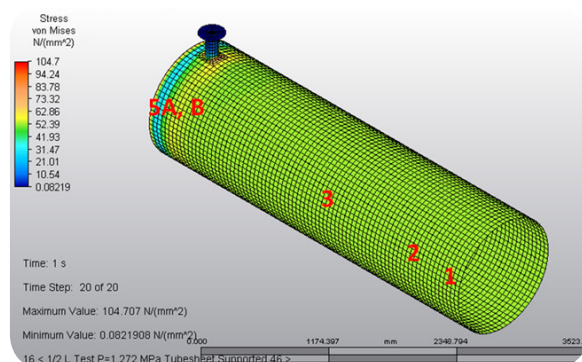
Strain gauges on shell

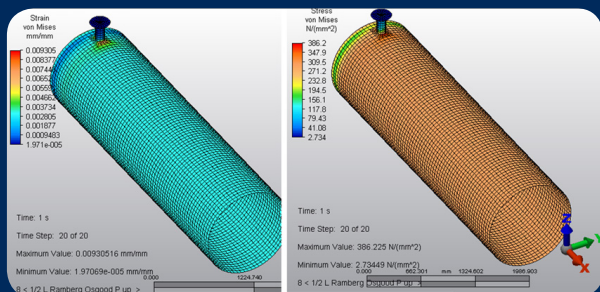
Upon the completion of the Fitness for Service engineering assessment, the following inspections were then prescribed based on the FEA (finite element analysis) results:

FEA Shell Model (Nonlinear)

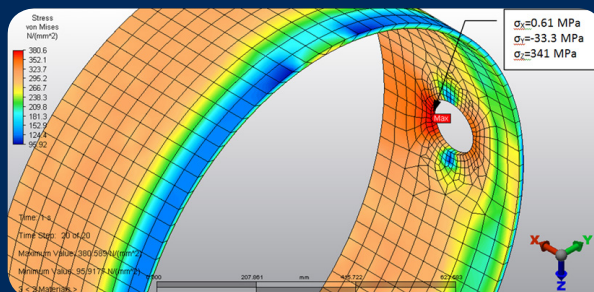
Stress Distribution in Shell
