PROJECT SPOTLIGHT FLARE STACK – EXTENDING OPERATING LIFE OF CRITICAL LEGACY ASSET

MINIMIZE RISKS AND EXTEND OPERATING LIFE

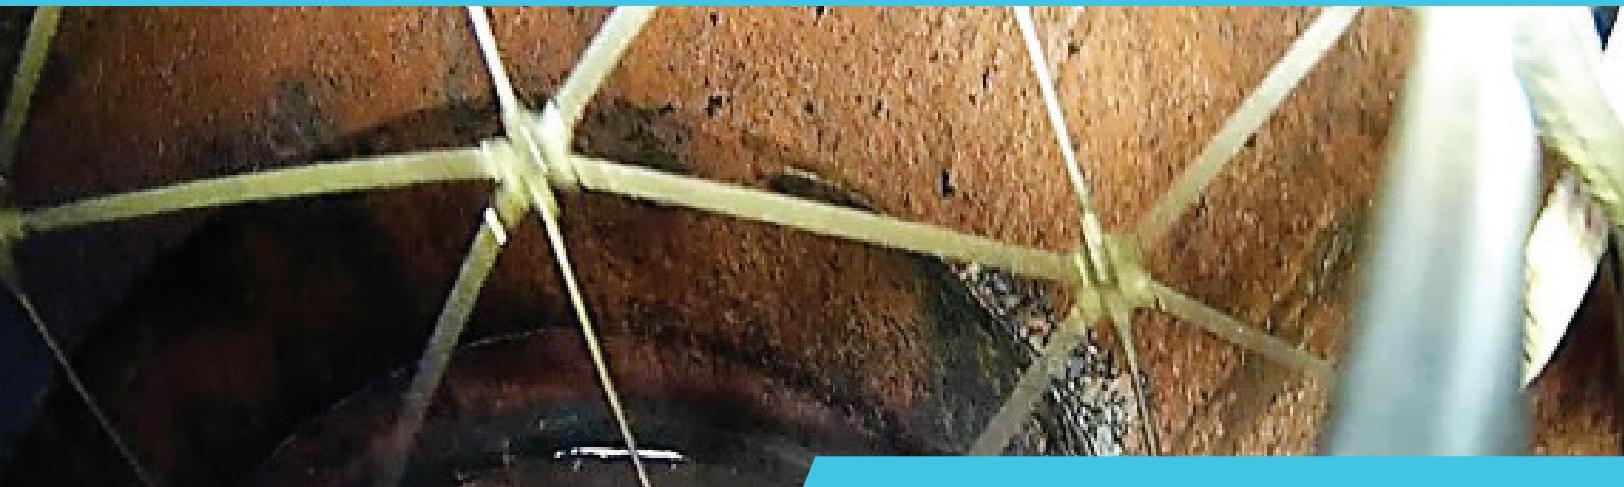
Site Inspection identified a number of concerns:

- Advanced thinning of top six (6) feet of stack pipe
- Large circumferential crack in stack pipe at flare tip flange
- Flare tip cracking
- Holes in stack pipe under clamps
- Slight progression of general thinning
- Failed ladder and piping attachments
- Cracking confirmed with internal drone

Integration of drones with engineering, inspection, assessment, repair processes, and work via rope access limited costs and outage duration with increased workflow efficiencies

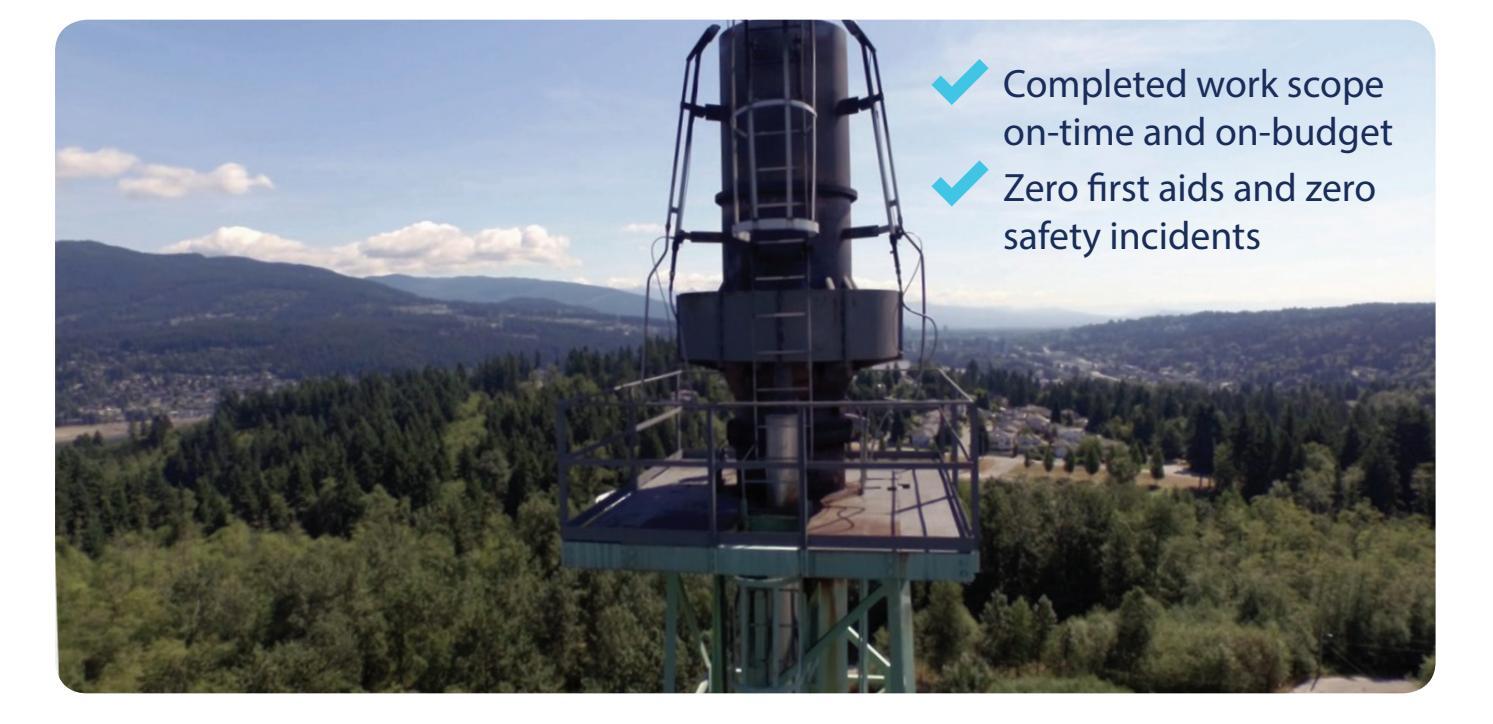
Various internal Acuren disciplines were required for a successful project

- This 25 person crew carried out the following work onsite:
- Welded 0.375" sleeve to address upper stack pipe thinning and flange cracking
- Welded sleeves to reinforce stack pipe at each clamp location
- New clamps installed with welding and bolted hardware per engineering design

- Repair of cracked ladder welds and attachments as well as pipe supports
- Ladder fall arrest safety system installed on all three
 (3) ladder sections
- Prepared installation details and drawings
- FEA conducted to verify suitability of additional found repair work
