# An Introduction to Coal Silo Failures

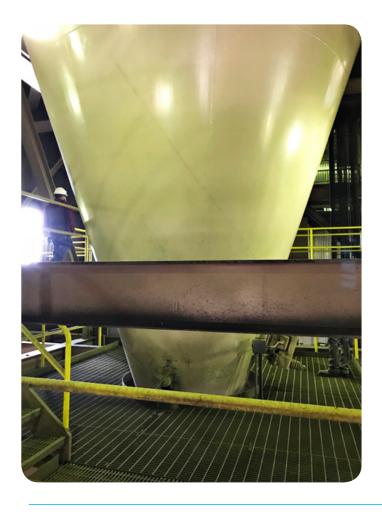
Acuren's inspection of the shell to weld dissimilar metal weld is done primarily with PAUT. Typically, a reference standard is made from the documented joint design with three EDM notches placed at potential crack propagation sites.

This reference standard shows that a plate is welded on the outside of the C/S shell preventing UT from being done from that point. For this particular project, our techs scanned the weld joint from the underside at the crotch of the cone and shell junction with a Cobra probe on the SS cone (angled piece). Acuren experts have also found large amounts of slag in the welds that has not caused cracking. They have seen significant amounts lack of fusion (LOF) at the backside of the joint as well. The significant cracks have been found to open on the inside weld at the HAZ.
