PROJECT SPOTLIGHT ACUREN HELPS FOOD INDUSTRY CLIENT PREVENT PIPE LEAKS

Acuren's Ammonia System Inspection group helped a food industry giant avoid a possible shutdown. Acuren's experts were tasked with inspecting the pipes and vessels involved in a 75,000 pound ammonia system in Arkansas.

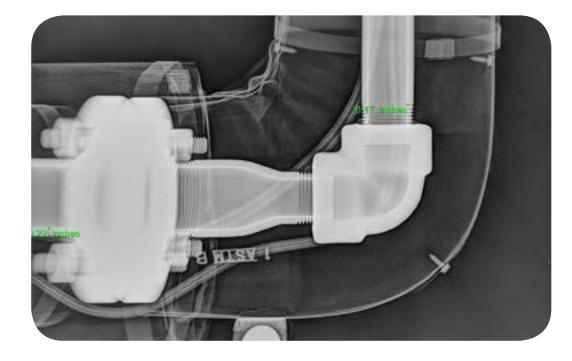
Acuren used an integrated approach to support the fortune 500 company by using a tandem of x-ray inspection methods. Digital radiography (DR) and real time radiography (RTR) was used to reveal areas of corroded pipe and areas

of concern. Integrating our inspection methods can help locate corroded pipe, instead of selecting random spots to perform ultrasonic testing to check for possible corrosion, many times resulting in unnecessary testing. Additionally, a combination of x-ray inspection methods allows the client to avoid costly insulation removal to view the pipe while also avoiding damaging of the jacketing.

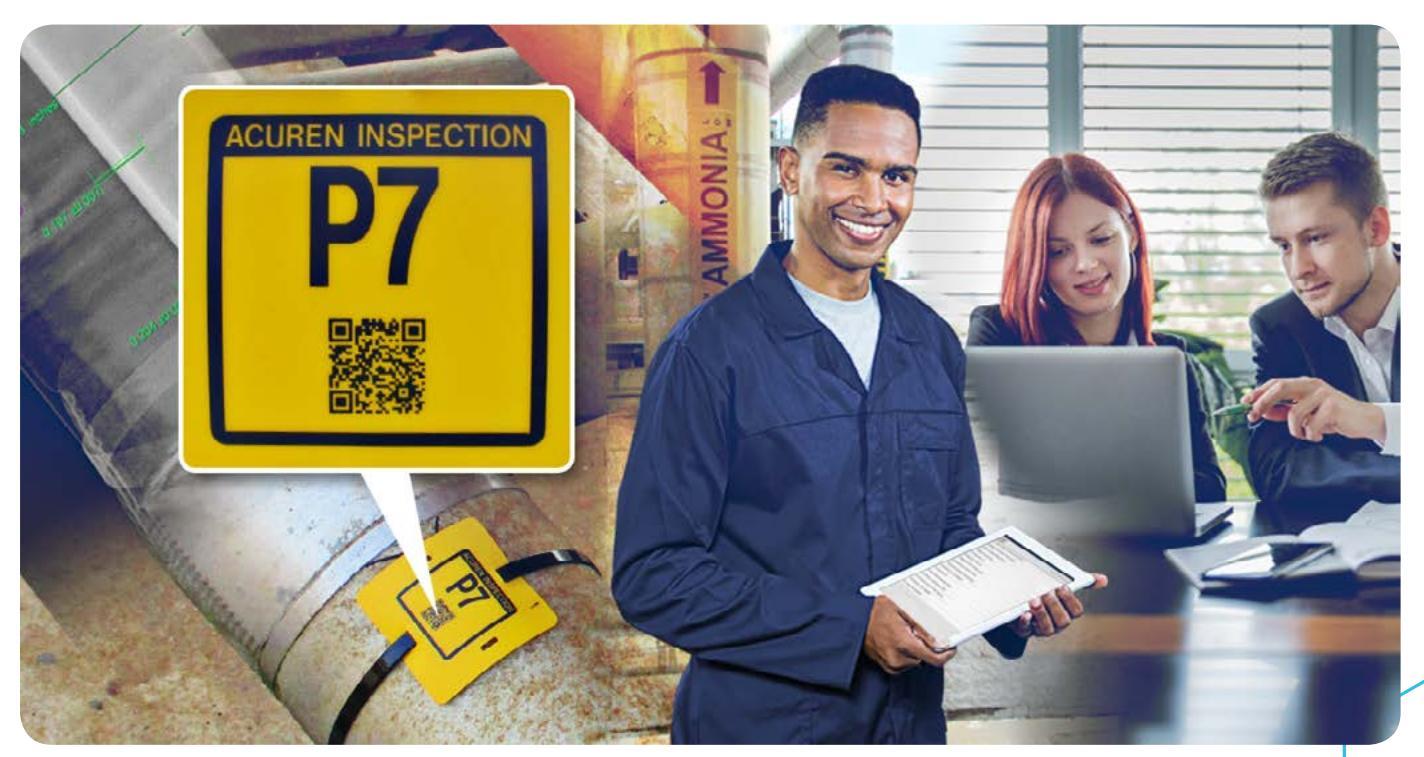
ACUREN 1940-0000 Customer/Contact						Ammonia Piping Profile Examination Report								Date: 5/20/2019 5GR 651836 POR: 4200497591 Unit/System: Annonala System Inspection				Thickness Data				
Location/Address:							-)							Description: Piping/Vessels								
Zone: Exterior: Engine Room																					-	
Exposure XRY Link	e Service JPG k Link	Location ID	Constr. Date	Inspect. Date	Pipe Dia: Sch.	Nominal Wali	Clent or Maril MW	Min(t) Found	Max(Q)/ NormNi	Percent Loss	Next Inspct.	Inspection Basis	lcing	Corresion	Moistune	Comments	Exposure	Location 8	Location 2	Location 8	Location 4	
<u>P07</u>	LTRL	AHU-19	1/1/90	5/21/19	1.50" Sch. 80	0.200	0.100	0.197	1.030	• 15	5/19/24	Reference CUI Scan # 2	None Visible	NONE / NEGLIGIBLE	Reavy Moleture	N/A	P07	0.197	0.199	0.204	0.206

At Acuren, we number and tag each test location, x-ray and scan. Every inspection point has a numbered tag with a QR code to identify specific locations in the online system.
